# Specifying the Clocking of Patterns of Features<sup>1</sup>

<sup>1</sup>Cogorno, Gene R., *Geometric Dimensioning and Tolerancing for Mechanical Design, Second Edition*, McGraw-Hill, New York, 2011, p. 239

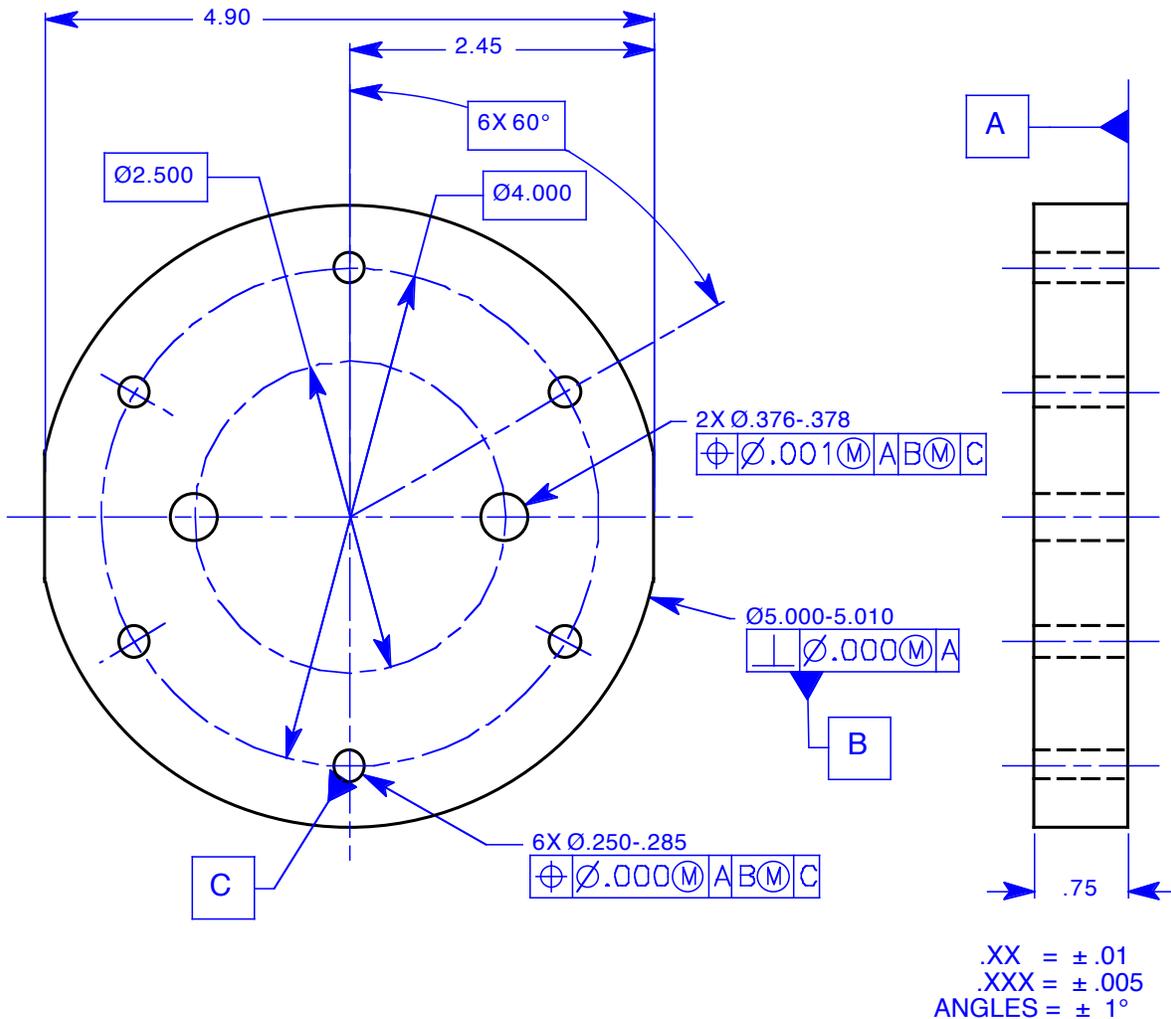
**Figure 1** An example of patterns of features incorrectly clocked to a datum feature.

In Figure 1, datum feature C is incorrect. The six-hole pattern is clocked to one of the holes in the pattern. It looks like the designer wants to control the clocking of the two hole patterns. The two patterns are locked together as one composite pattern, but datum feature C is free to rotate anywhere around the axis of datum feature B as long as it is on the Ø4.000 bolt circle. Consequently, the two hole patterns are free to follow datum feature C.

1. There is no need to clock the other five ¼ inch holes to the sixth hole, datum feature C, because angular separation between the six holes on the basic 4-inch diameter bolt circle has been accomplished with six basic 60° angles.

2. The engineer may have been trying to clock the two-hole pattern to the six-hole pattern. But that has already been accomplished, since multiple patterns of features are to be considered one composite pattern if they are located with basic dimensions, have the same datums, in the same order of precedence, and at the same material conditions. This is the case here. Datum feature C is not required to clock the two patterns to each other. A better way to clock the two-hole pattern to the six-hole pattern is shown in Figure 2. In this case, the two hole patterns are clocked together as multiple patterns of features, explained above, however they are free to rotate about the axis of datum feature B.

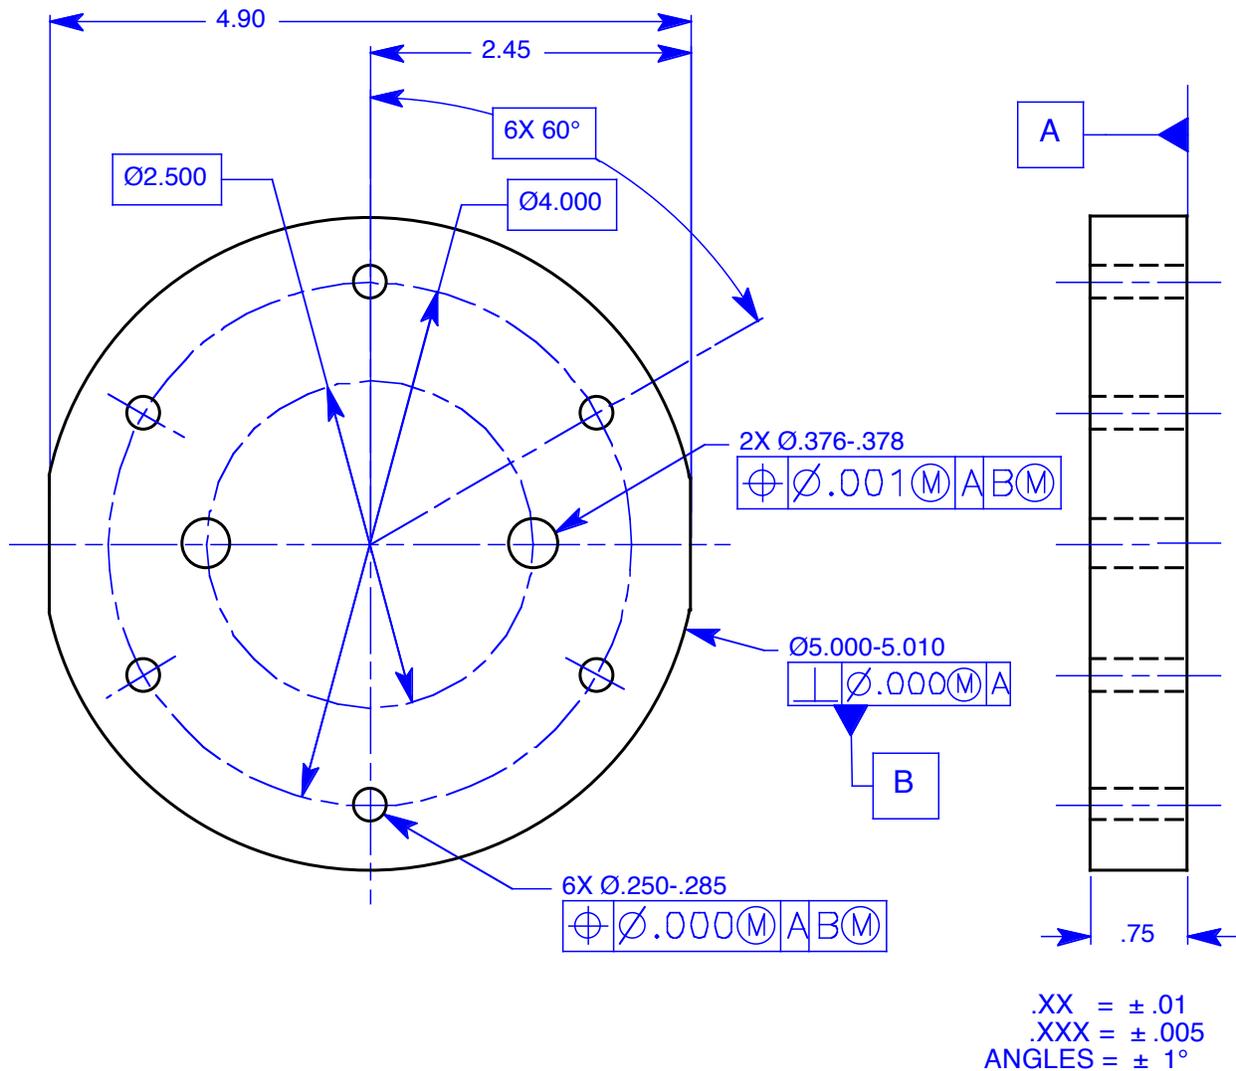
**Figure 2** A correct example of patterns clocked only to each other but free to rotate around the axis of datum feature B.

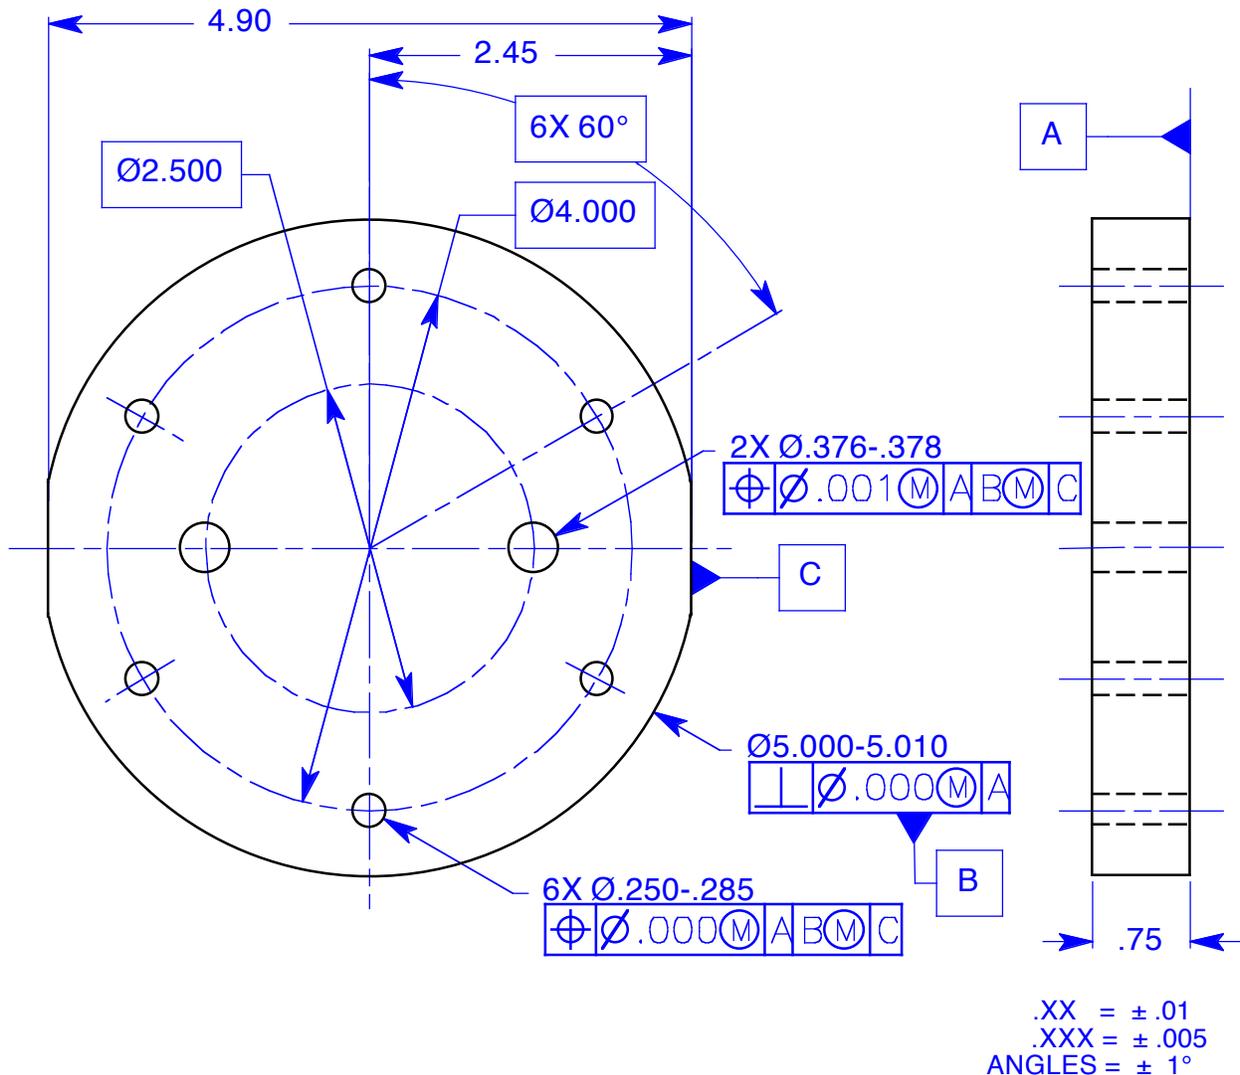
**Figure 3** A correct example of patterns of features clocked to each other and to datum feature C.

In Figure 3, the two position controls specifically orient the hole patterns perpendicular to datum feature A, locate the bolt circles to the axis of datum feature B at maximum material boundary, clock the patterns to the flat, datum feature C, and lock the two patterns together as one composite pattern. The flats on each side of the part are parallel to each other within the title block tolerance of ± 1°.

3. It appears that the engineer was trying to clock both hole patterns to one or both of the flats on the 5-inch outside diameter since the flats are located to the center plane that passes through two of the holes in the six-hole pattern. If this is the case, one or both of the flats should have been specified as datum feature C as shown in Figure 3.

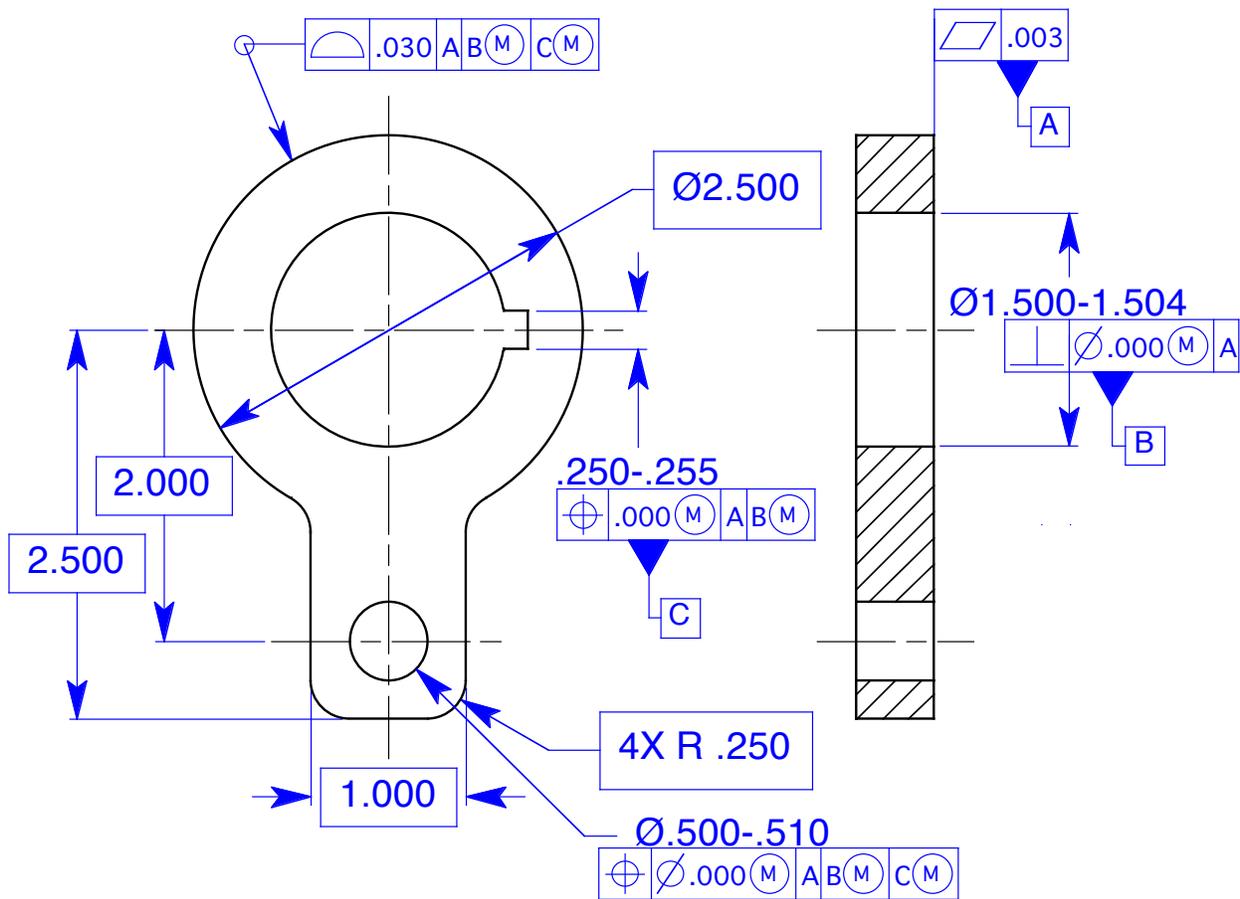
**Figure 4** A good example of features clocked to a datum feature.

The datum selection, the datum sequence, and the application of geometric controls were all very well done on the drawing in Figure 4.

1. The primary datum feature, datum feature A, is required to be flat within .003.
2. The secondary datum feature, the Ø1.500 hole identified as datum feature B, is oriented to datum feature A within a zero perpendicularity tolerance at maximum material condition. This means that if the diameter of the hole, datum feature B, is produced at 1.502, the hole may be out of perpendicularity by .002 and still be within tolerance.

3. The keyway is perpendicular to datum feature A and located to Datum feature B within a zero positional tolerance at maximum material condition. In other words, if the keyway is produced .253 wide, it may be out of perpendicularity to datum feature A and out of position to datum feature B within a tolerance of .003.

4. And finally, both the Ø.500 hole and the profile have been properly oriented, perpendicular to datum feature A, located to datum feature B at maximum material boundary, and clocked to the keyway, datum feature C at maximum material boundary. The Ø.500 hole and the profile are locked together as one composite pattern.
